David G. Miller & Associates

INSPECTION AGREEMENT

Address of Subject Property: XXXX Meadow Dr, Springfield, IL XXXXX

Whole House Home Inspection

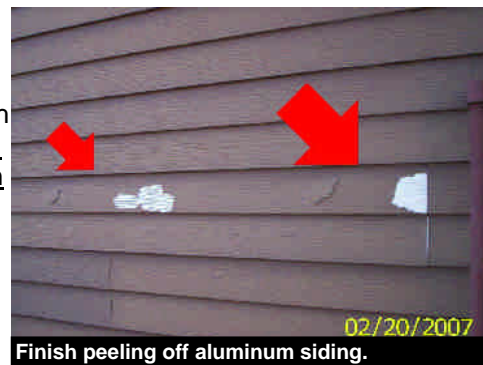
CONDITION: Aluminum siding; Brick, Veneer (front)
Deficiency: The finish is peeling off various areas of the aluminum siding on the east side of the house/garage. This appears to be a manufacture finish failure. Recommend further evaluation by a qualified manufacturers technician and repair or replace as needed.

Finish peeling off aluminum siding.

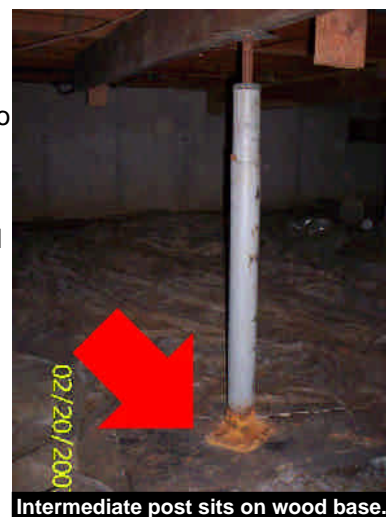
Intermediate post sits on wood base.

Note: Various steel intermediate support posts are installed and sit on a wooden base. Intermediate support posts and beams are often installed by home owners to reduce deflection (bounce) in the floor system. Wood base's often decay due to moisture. A concrete support base is the recommended method to support any type steel post.

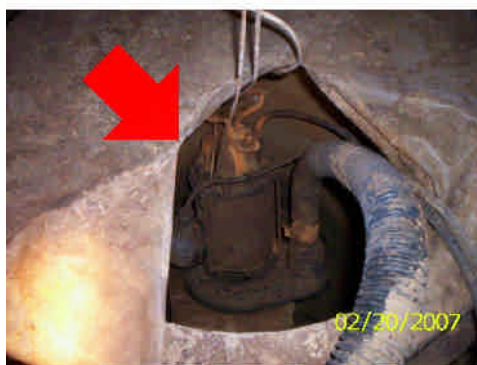
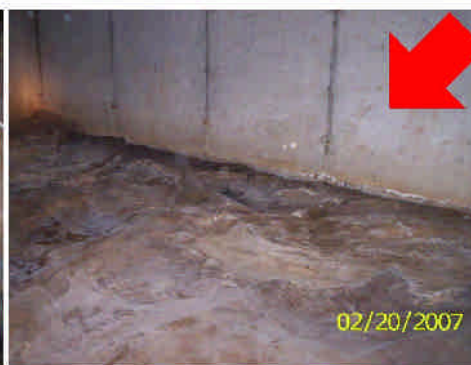
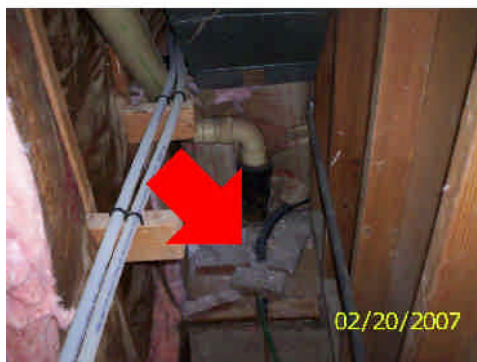
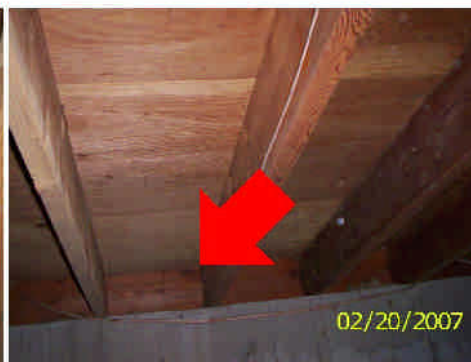
Crawlspace insulation installed: No crawlspace insulation is installed. Modern standards suggest insulating the box sill (band joist) area to a R-19 value and along the foundation wall to a R-8 value, using foam or fiberglass insulation for improved energy savings.

Sump Pump views (L) -- No insulation (R)

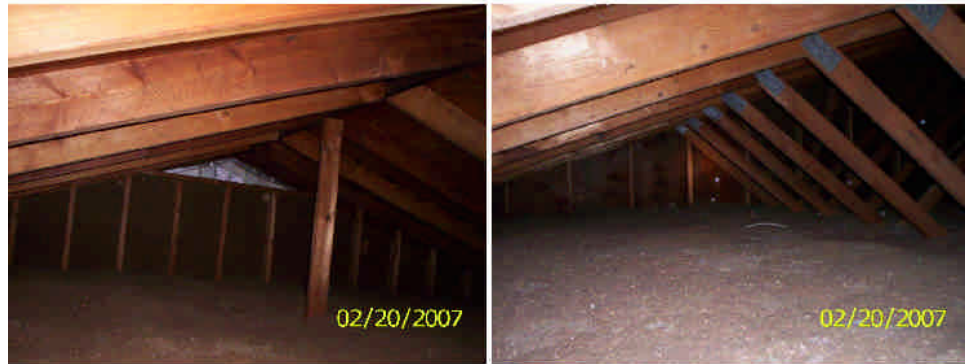
East attic view (L) -- West attic (R)

Type: Fiberglass batts with Cellulose insulation blown over-top.
Insulation is installed between roof trusses or attic floor joists next to ceiling.
Appears serviceable.

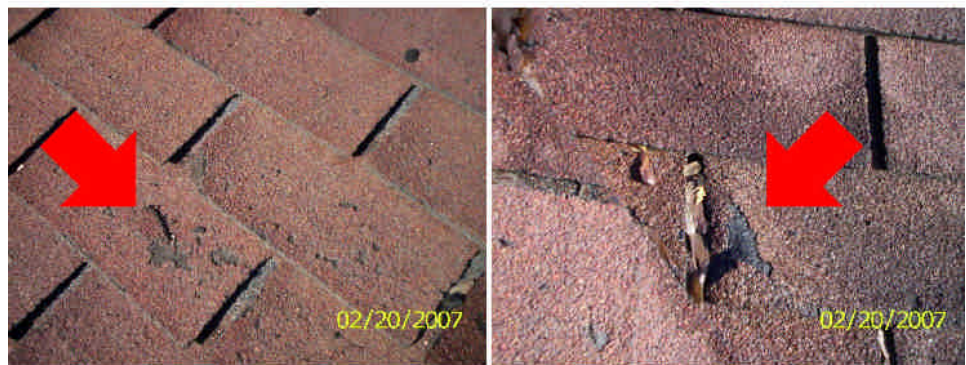
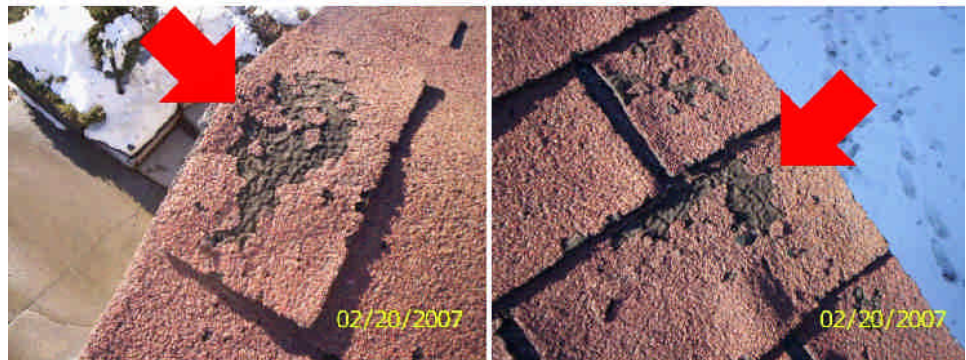
Roof appears to be near the end of its useful life. Recommend consulting with a licensed roofer for further evaluation and cost estimates for replacement in the near future (less the 5 years).

Signs of aging roofing materials.

General condition appears serviceable with typical signs of weathering/curling, cracking, and minor granule loss which is due to age. Regular maintenance and inspections are advised.

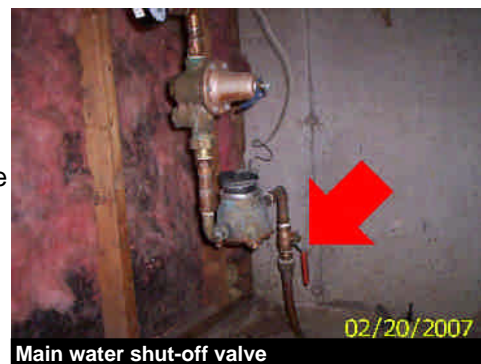
MATERIAL: Copper, 3/4" service.
CONDITION: Main water shut-off valve located: the southeast corner of the crawlspace.
Appears serviceable.

In the Macomb area, due to acidic water, copper service pipe may corrode with age and eventually leak. The Homeowner is responsible for their water service pipe from the house to the street. It is not within the scope of the Inspection to evaluate buried copper water piping (see Inspection Agreement). One should monitor their water usage to determine if significant leakage has occurred.

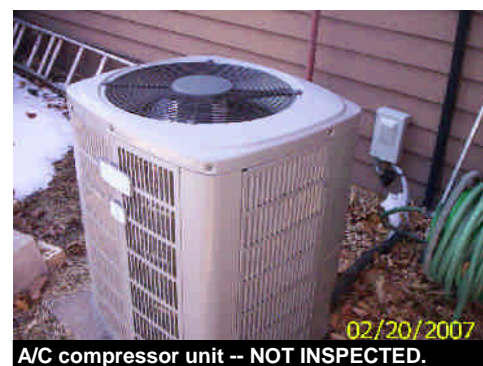
Not Inspected: If the outside temperature has not been at least 60 degrees F. for the past 24 hours, an air conditioner system cannot be checked without possibly damaging the compressor. We recommend further evaluation as weather permits, or, that the present owner of the property warrant the operational status of the unit on a one-time start-up and cool-down basis when warmer weather permits, or, purchase of a "Home Buyer Warranty" policy.

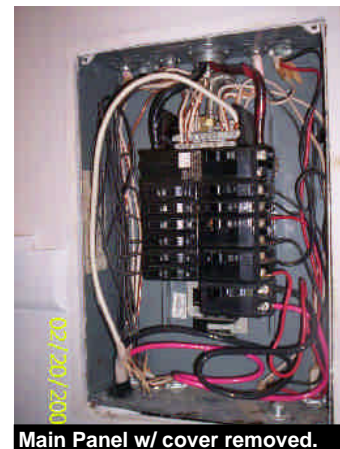
Deficiency: A 220 volt wire, lower left corner of panel, enters the panel without proper "strain relief" (ie; wire clamps or protective plastic grommets). This is to secure the wire into the panel and to protect the wire from possible sharp metal edges of panel openings. I recommend that a licensed electrician make a full system evaluation and corrections as needed.

Main Panel w/ cover removed.

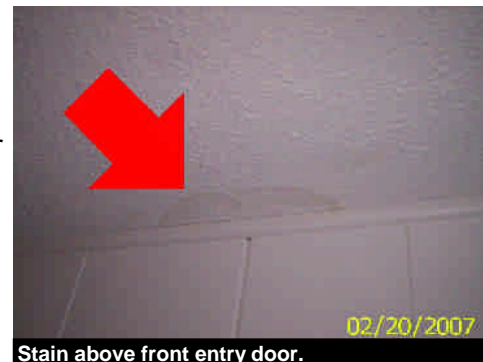
Stains noted above the front entry door may indicate past or present leakage from the roof. Determining the source of the moisture stains is beyond the scope of the inspection. Recommend to monitor and repair if needed.

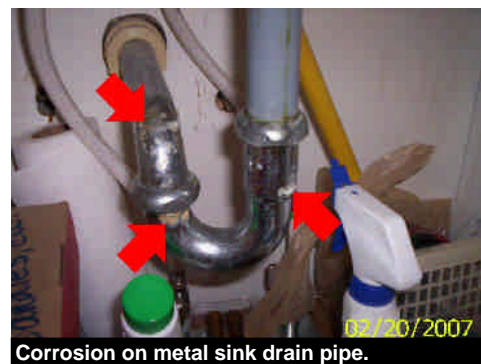
Corrosion noted on the sink drain pipe.
This may eventually allow the pipe to leak. Recommend to monitor and repair as needed.

Corrosion on metal sink drain pipe.

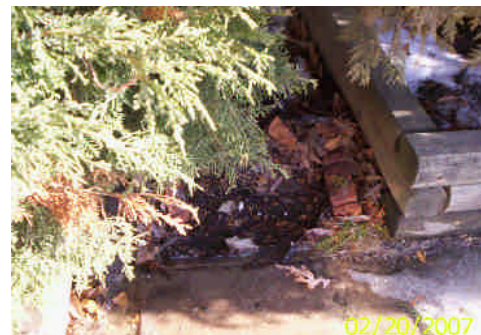
Note: Recommend to regularly monitor the driveway drain to prevent clogging with leaf/lawn debris. If the drain were to be come clogged, it may allow water to flood into the garage.

Driveway drain on east side of drive.
